# Manhole Inspection Summary

Manhole # S35II1015MH

**Location** Address: **4100 GREENWAY**

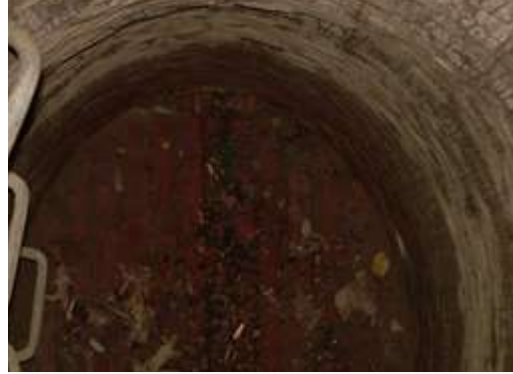
Top View

Channel debris.

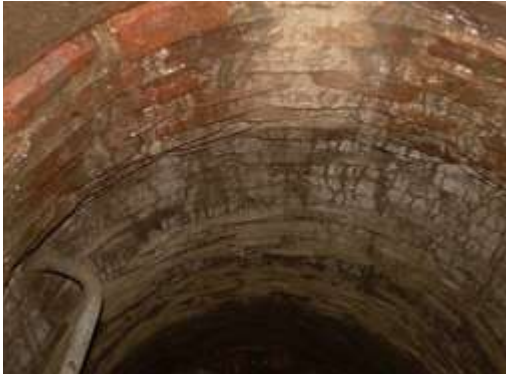
Defect

Condition: ☐ Sound ☐ Cracked ☐ Root Intrusion ☐ Loose Brick ☒ **Deteriorated**

Infiltration: ☐ None ☒ **Joint** ☐ Cracks ☐ Mortar ☐ Roots ☒ **Wall**

Infiltration: ☐ None ☐ Joint ☐ Cracks ☐ Mortar ☐ Roots ☒ **Wall**

Corbel deterioration and infiltration. Barrel infiltration.

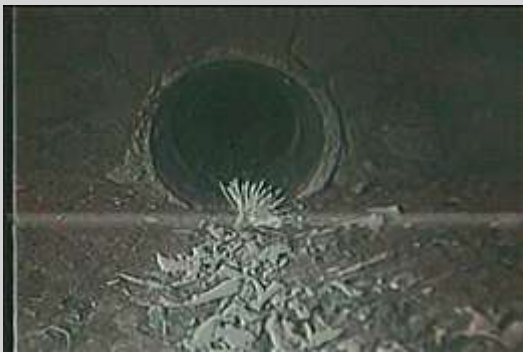
8 in. Circular Gravity Sewer  
Pipe Out @ 12 O'Clock

Deposits: ☐ None ☒ **Mud** ☐ Sludge ☒ **Debris** ☐ Grease

Silt Depth: **0** (in.) Deposits Extent: **Light**

Infiltration: **None** Pipe Seal Cond: **Cracked**
